Manhole Inspection Summary

Manhole # S25GG_035MH

Insp Date: **9/10/07 9:53 AM**

Location Address: **584 PRESSTMAN ST**

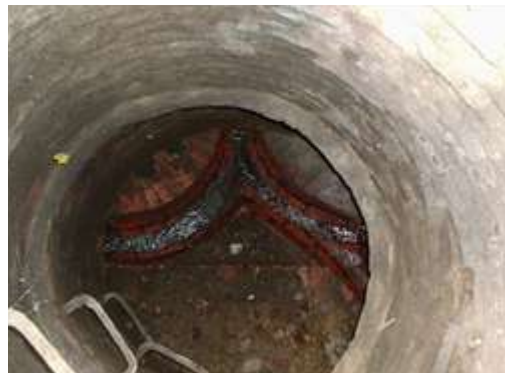
Top View

Corroded steps. Evidence of surcharge - Bench debris.

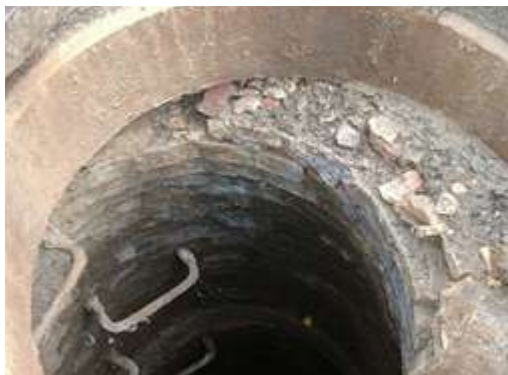
Defect

Frame leaks. Frame offset. Adjustment deterioration, loose brick and infiltration. Corbel and Barrel infiltration - other side.

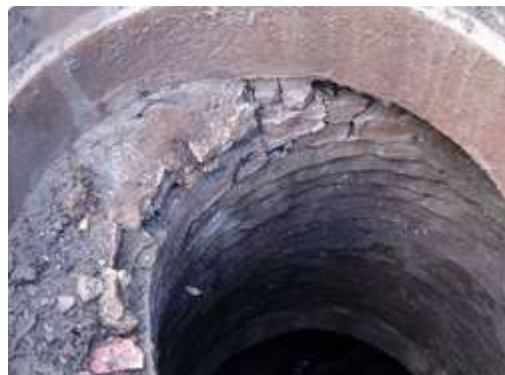
Defect

Frame leaks. Frame offset. Adjustment deterioration, loose brick and infiltration. Corbel and Barrel infiltration.

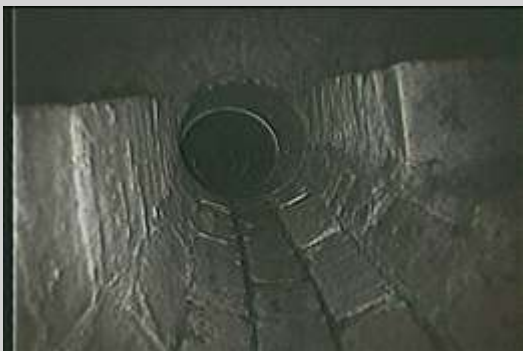
8 in. Circular Gravity Sewer Pipe In @ 3 O'Clock

Infiltration: **Evidence** Pipe Seal Cond: **Cracked**

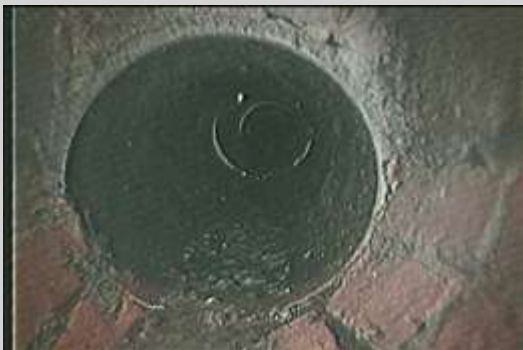
Pipe In @ 9 O'Clock

Deposits: ☐ None ☒ **Mud** ☐ Sludge ☒ **Debris** ☐ Grease

Silt Depth: **0** (in.) Deposits Extent: **Light**

Infiltration: **None** Pipe Seal Cond: **Cracked**
